# **An Archaeological Assessment of Excavations Undertaken at the Lufton Roman Villa, Brympton, Somerset, 2016-2017**

**James Gerrard and Andrew Agate  
School of History, Classics and Archaeology  
Newcastle University  
2021**

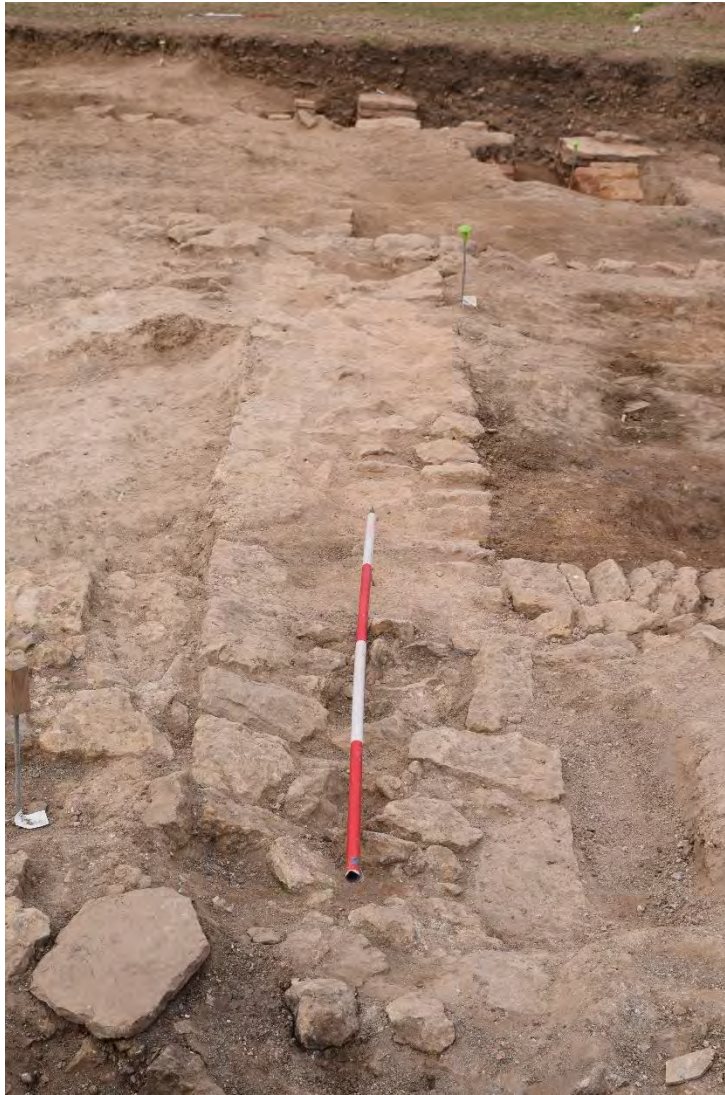
*Figure 7 The northern half of wall [111] (looking north. The butt joint of wall [151] is visible in the foreground and wall [178] in the background.*

The main and seemingly primary elements of the building are walls [111] and [178] and [114], which form the western and northern walls of Rooms 5 and 6 (Figs 7 and 8). Wall [111] survived three courses high (with the first course offset) in the south but was reduced to a wall head north of Room 5. It was constructed of roughly hewn Yeovil Stone and Hamstone laid in regular courses and survived for a length of at least 6.83m. At its northern end wall [178] joined [111] at a right angle (the precise relationship of these walls could not be determined but it seems likely they were of one build). This wall, also constructed of roughly hewn Yeovil Stone and Hamstone seemingly laid in regular courses, was exposed largely as a wall head, although where it formed the southern side of the hypocaust channel for Room 6 [120], it was four courses high. The quality of the stone work in [120] was of somewhat better quality. North of the hypocaust channel the wall continued as [114]. What struck the authors and Hayward (1972, 65) was the thickness (1.2m) of this wall.

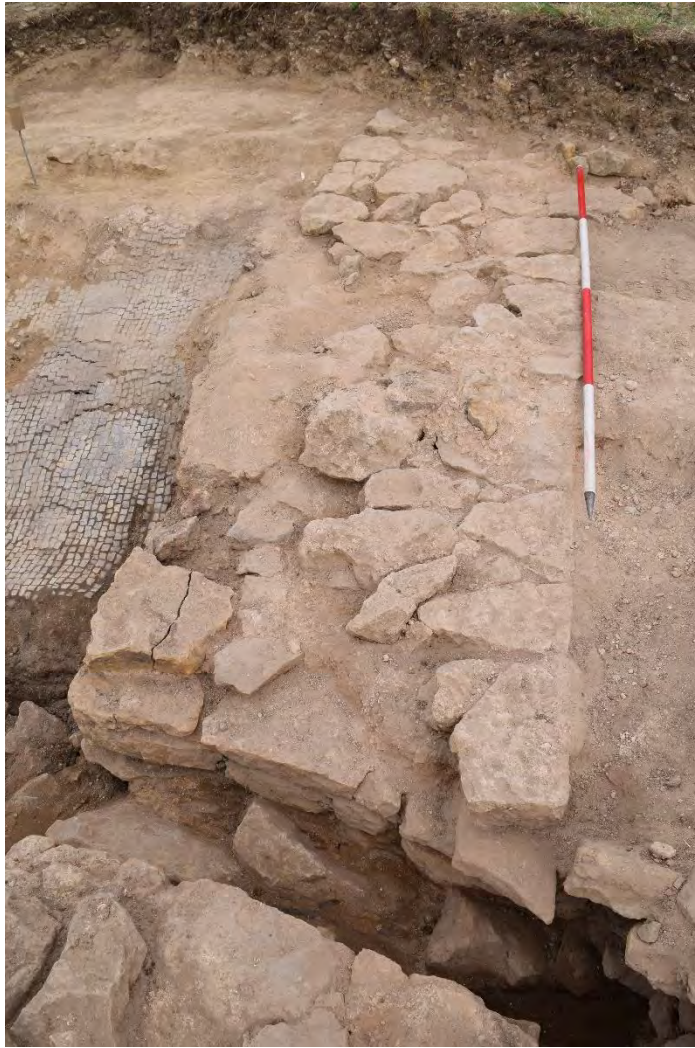
*Figure 8 Wall [114] looking east. Note the width.*

Hayward (1972, 65) offers no explanation for the great thickness of this wall. What seems clear from the current excavations is that [114/178] must be the northern end of the southern group of rooms. The villa was laid out across a considerable slope and measurements on the modern ground surface reveal an observable fall in slope as follows: 51.23m AOD (South West Corner Trench A); 50.61m AOD (North West Corner Trench A) and 49.64m AOD (North West Corner Trench B). Terracing, as Hayward observed in another context (Hayward 1952, 96), must have been necessary for the building to function. This falls into even sharper focus given that we can demonstrate that the difference in height between the base of the hypocaust flue for Rooms 10 and 11 and the wall head [178] (at the same approximate physical level as the early deposits in Room 6) is 86cm. The difference between the base of the hypocaust flue and the stratigraphically high oven feature [142] in Room 6 is 101cm.

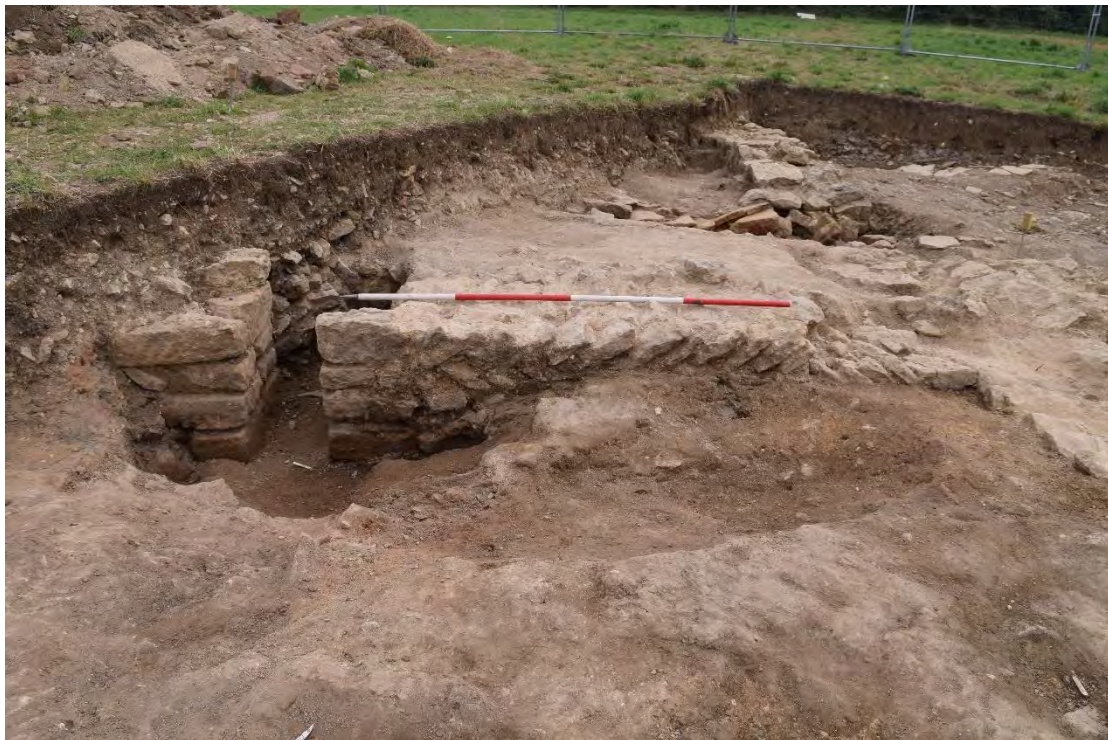
*Figure 9 Wall [157] and hypocaust channel with Hamstone lining [112] and [113]. The southern end of wall [111] is also visible.*

Approximately half way along the length of wall [111] exposed in the trench a cross wall [157] was identified (Fig 9). This wall, constructed of roughly hewn Yeovil Stone, was of herringbone construction. It terminated in neatly laid and dressed Hamstone blocks [112] that formed with similarly constructed [113] either side of a hypocaust channel that ran through this dividing wall between Rooms 5 and 6. What is clear is that [157] was not bonded with [111] and this partition wall must have been inserted after the exterior walls were erected.

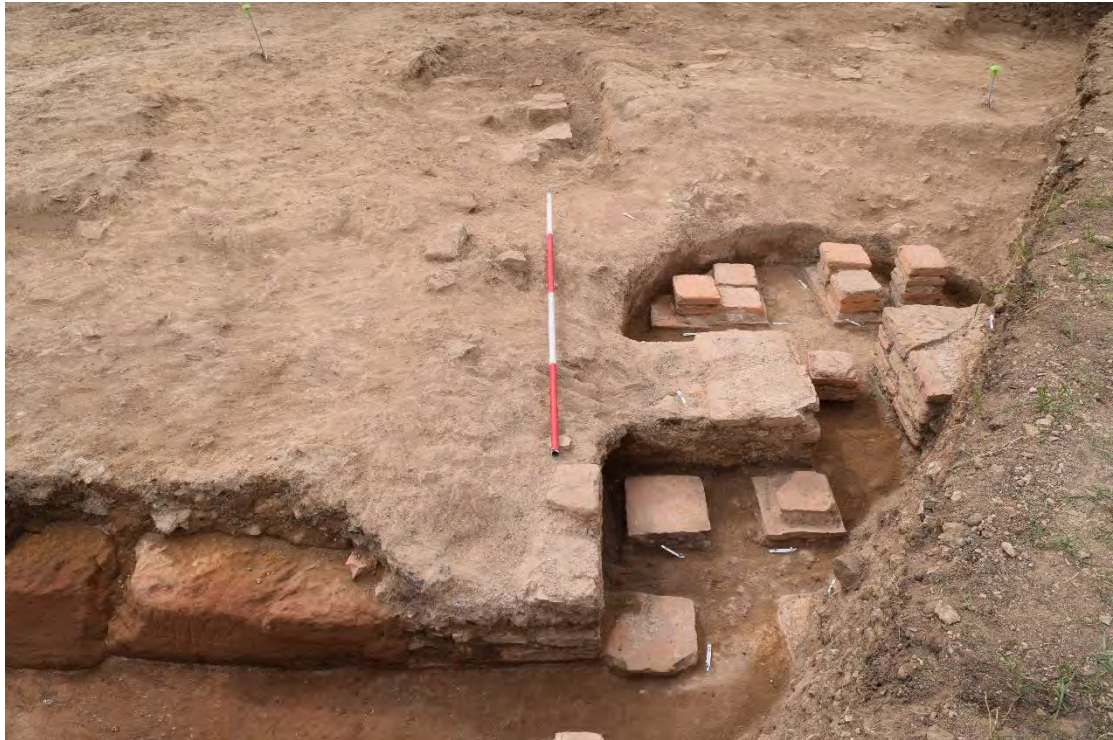
*Figure 10 Rooms 10 and 11 [Structure 170] looking west.*

Rooms 10 and 11 were apparently contemporary builds and described as Structure [170] (Fig 10). This was exposed by removing the fills of Hayward's trench (Phase G) and the surrounding walls appeared to be sealed by horizontal stratigraphy running south. The apse [183] was separated from Room 10 by walls [185] and [187] and the southern wall of Room 10 was numbered as [184]. These were well-constructed from regularly coursed and worked Yeovil Stone and lined with a pink mortar/concrete on the interior. On this surface the *pilae* stacks were constructed from CBM. The apse had two L-shaped supports made from three *pilae* each ([194] to [196] in the south, [197] to [199] in the north). The flue running through the crosswall [185/187] between Rooms 10 and 11 also contained a *pilae* stack [193]. Additional *pilae* or the bases of *pilae* stacks were set upon the floor of Room 10 ([189]-[191]).

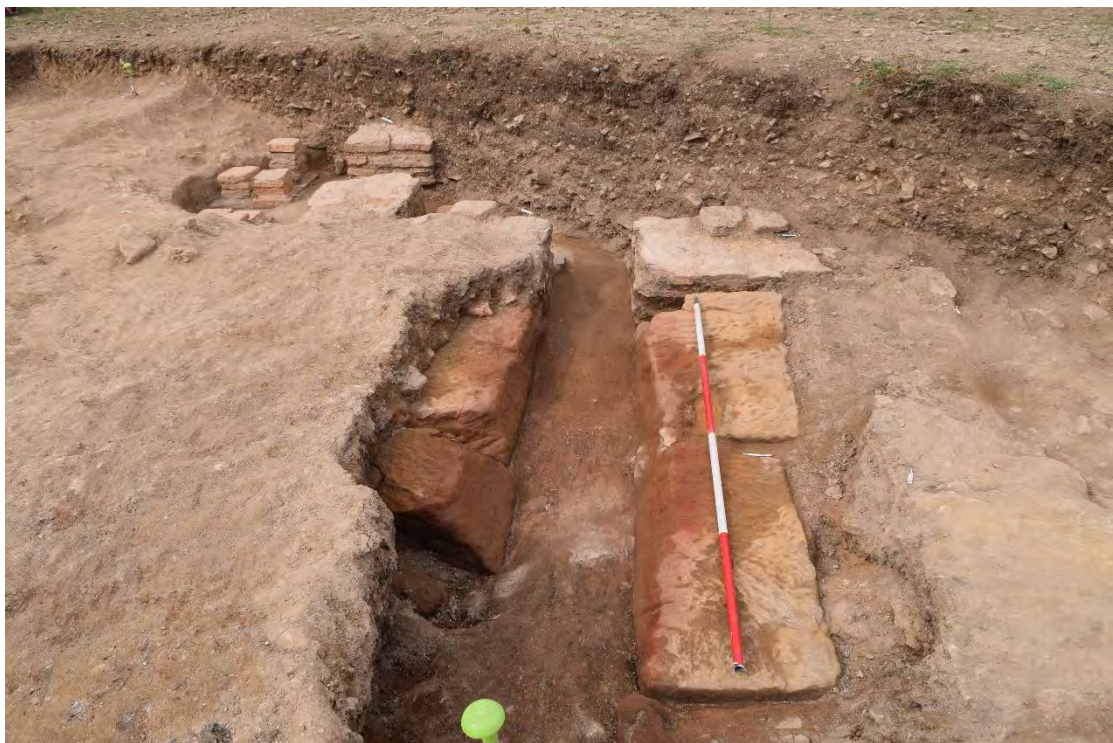
*Figure 11 The hypocaust flue for Rooms 10 and 11 (visible in the background). The fire reddened blocks of hamstone.*

To the south of Room 10 and joined to it by a flue that ran through [184] was the external furnace / flue [182]. This was made from very large blocks of Hamstone, which were separated by a channel that narrowed towards its base. The edges of the Hamstone blocks were fire-reddened by heat (Fig 11).

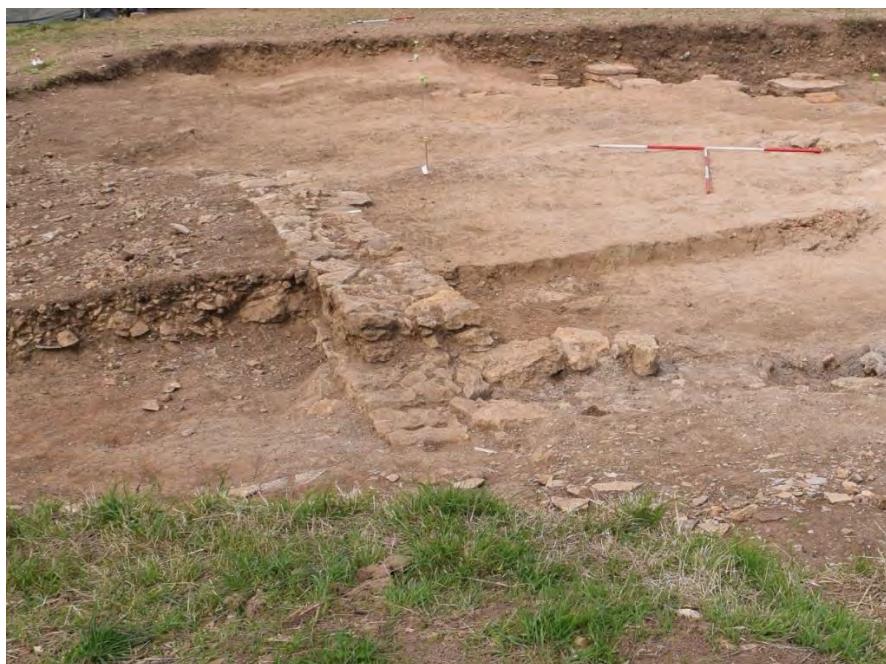
*Figure 13 Trench A looking north: Wall [110] and remnants of wall [134], which are keyed into [110].*

The 'new room', which we identified to the west of Rooms 5 and 6, was primarily defined by wall [110] (Figs 13-15). This was two courses, built on top of an offset basal course, of roughly hewn regularly coursed Yeovil Stone with some Hamstone. It ran for 6.72m parallel to wall [111]. At the southern end of [110] a wall line was identified running between [110] and [111] and forming the southern end of the wall. This line of this southern wall survived primarily as a robber trench [133]. However, at the western end some coursed Yeovil Stone blocks [134] were identified and observed to be keyed into [110] and thus of one build with it. At the eastern end of the robber trench further Yeovil Stone blocks marked the terminus of this wall [119], abutting [111] and thus later than it (Fig 14). The northern end of the room was closed by another seemingly heavily robbed wall. This was marked at its western end by a single stone [212] and at its eastern end by Yeovil Stone wall remnant [179]. Together these appear to mark a wall line that closed the northern end of this room. To the north of wall [110] was a thick deposit of smashed lias rooftiles [121] that would overlie any continuation northwards of [110]. Presumably these rooftiles are evidence for the materials that roofed the 'new room'.

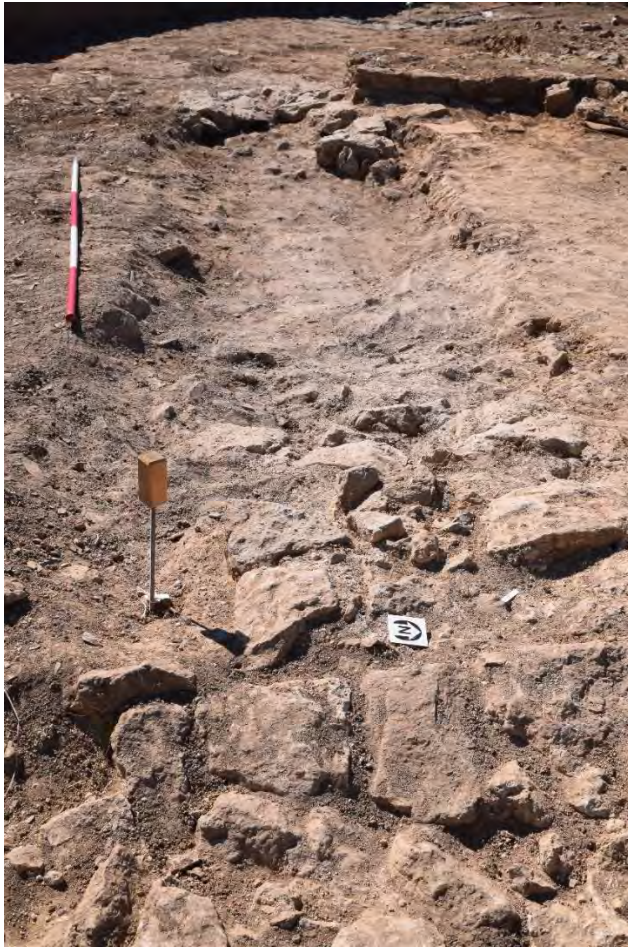
Figure 14 Robber cut [133] looking west. In the foreground the relationship between wall [110] and [119] can be observed and in the background wall [110] and remnant [134] are visible.

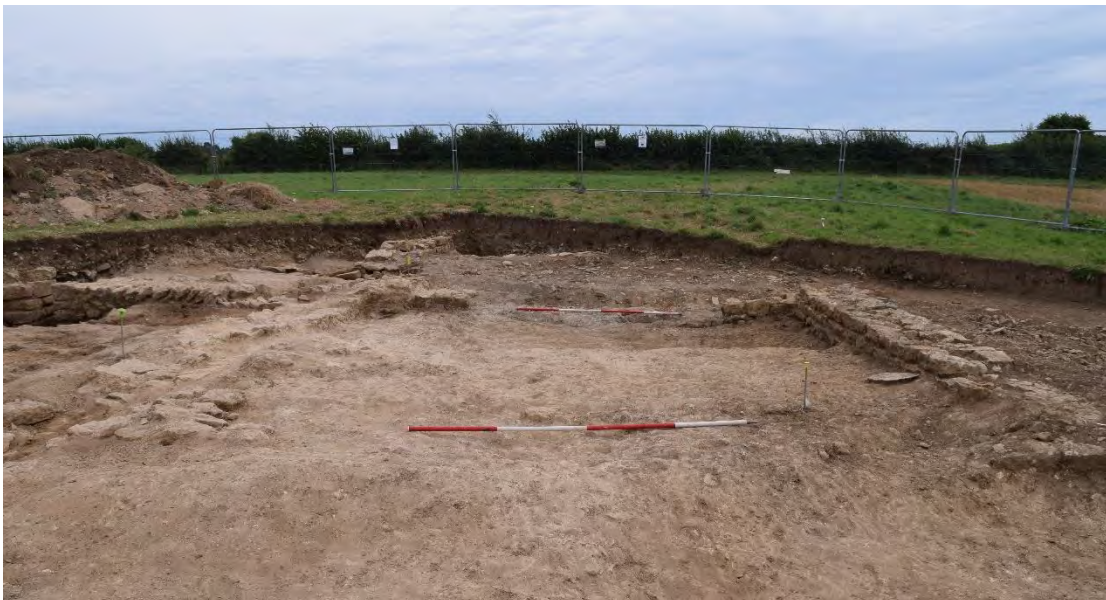
Figure 15 The 'new room' looking south. At the right handside (western) of the image and in the foreground the end of wall [110] can be seen and its return eastwards as [212]. At the left handside (eastern) wall remnant [179] is visible.

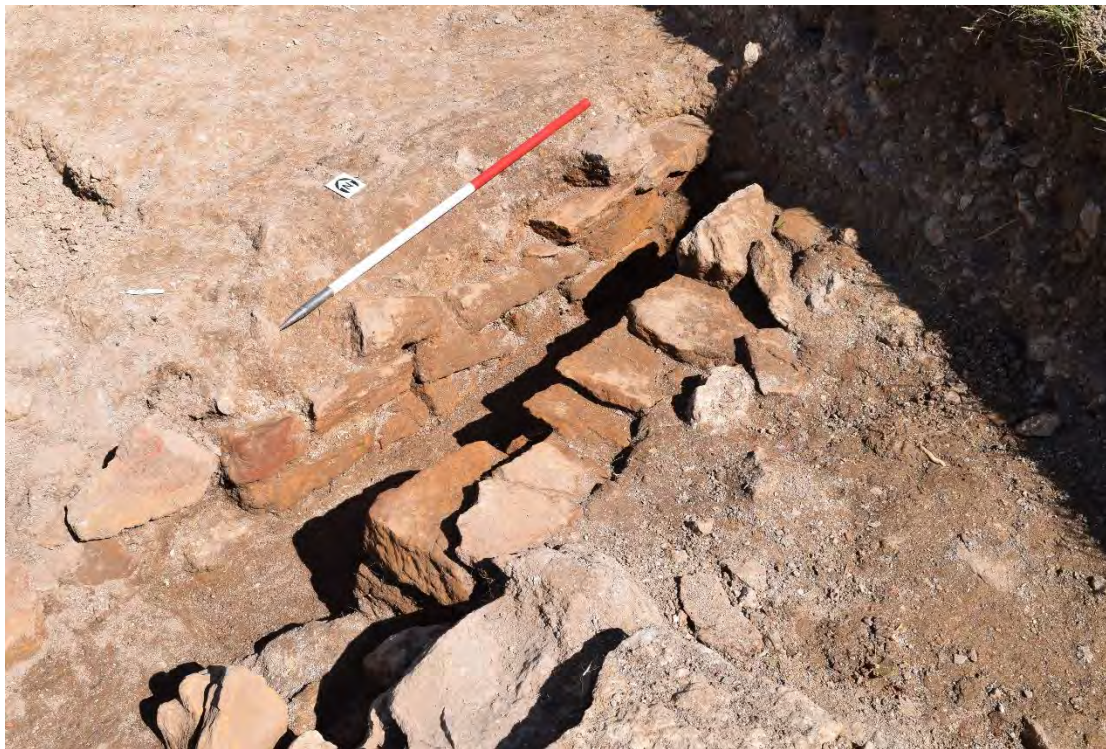
*Figure 16 Hypocaust channel in Room 5. Note the burning on the stones at the western end, towards the location of Hayward's stokehole.*

In Trench A only a small part of Room 5 was exposed in the south-east corner and to the east of wall [111] and this area was barely investigated by the present excavation. The main discovery was a length of channel that ran through the wall to the limit of excavation. The sides were made of neatly coursed hamstone blocks [167], which contrasts with Hayward's (1972, 65) description of this hypocaust having herringbone masonry (Fig 16). The full extent to the west was not determined beyond the line of wall [111], but it was noted that some upright hamstone pieces were burnt red on their edges in this area. This presumably relates to Hayward's stokehole found in his Trench XLI. The fill of the channel was a firm to soft grey clay with occasional charcoal flecks, moderate creamy yellow mortar flecks and fragments along with occasional pieces of stone and CBM [176]. The general impression was of a very mixed and disturbed deposit. Hayward's (1972, Fig 3) plan would seem to suggest that he had not excavated this part of the hypocaust. If this was the case then it might suggest that the channel had been infilled with [176].

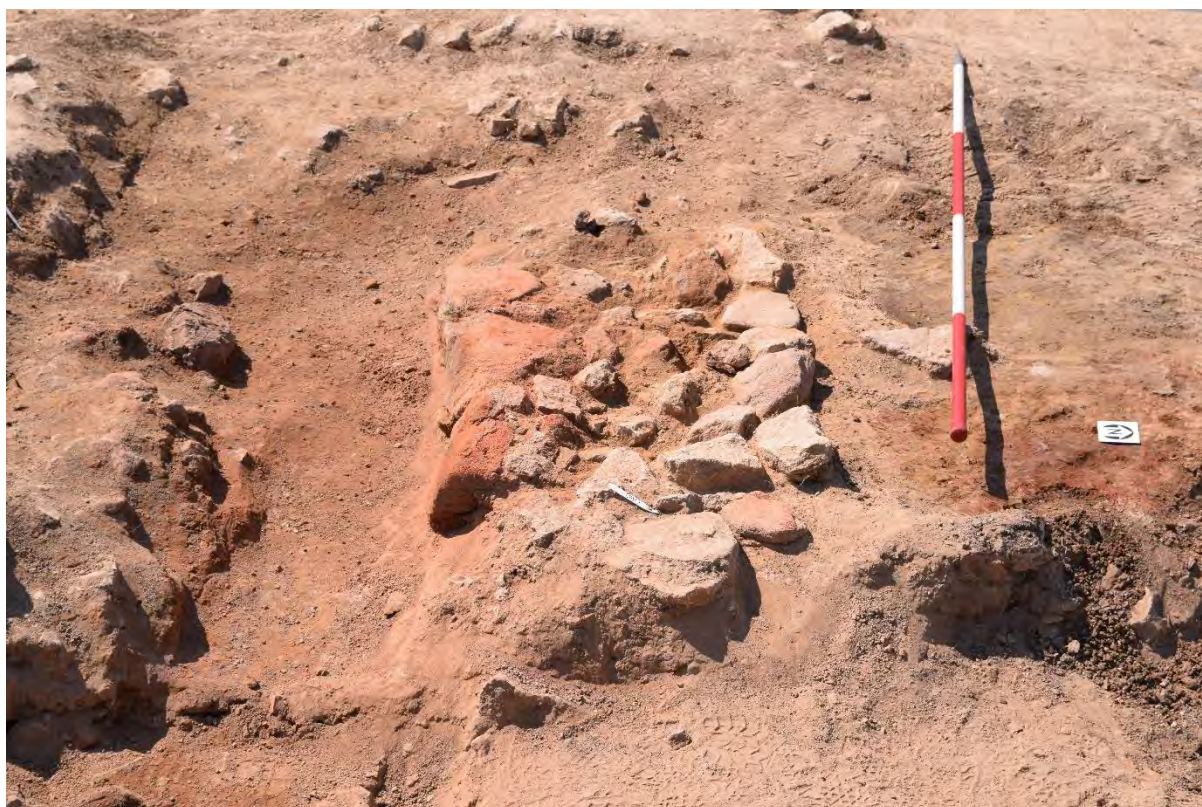
Figure 17 Possible remnants of a stone-lined oven or graindrier flue [142]. Note the burning on southern edge of the northern side and the robbed/disturbed southern side of the feature.

To the north of [205] a series of thin, interleaving burnt deposits (Figs 17-19) containing charcoal sealed [177]. The earliest of these was firm reddish brown silty clay [177],

Both layer [159] and fill [204] were cut by [141], a butt-end of a linear cut running parallel with wall [151]. This feature appears to have been a construction cut for a length of burnt stonework [142]. This survived on the north side as a heavily burnt stones lining a flue and backed by unburnt stonework. The south side appeared to have been robbed or disturbed but a few burnt stones marked the other side of a flue channel. Within the flue was deposit [135], a soft dark greyish brown sandy silt with pinkish patches and charcoal inclusions. This fill contained 11 fresh sherds of BB1. A Type 25 bowl was present and two heavily burnt body sherds decorated with just diagonal burnished lines. This vessel is likely to be a Type 18 bowl of late fourth or early fifth century date (Gerrard, this volume). The northern side of the flue was overlain by a firm yellowish brown silty clay [140] containing four sherds of BB1.

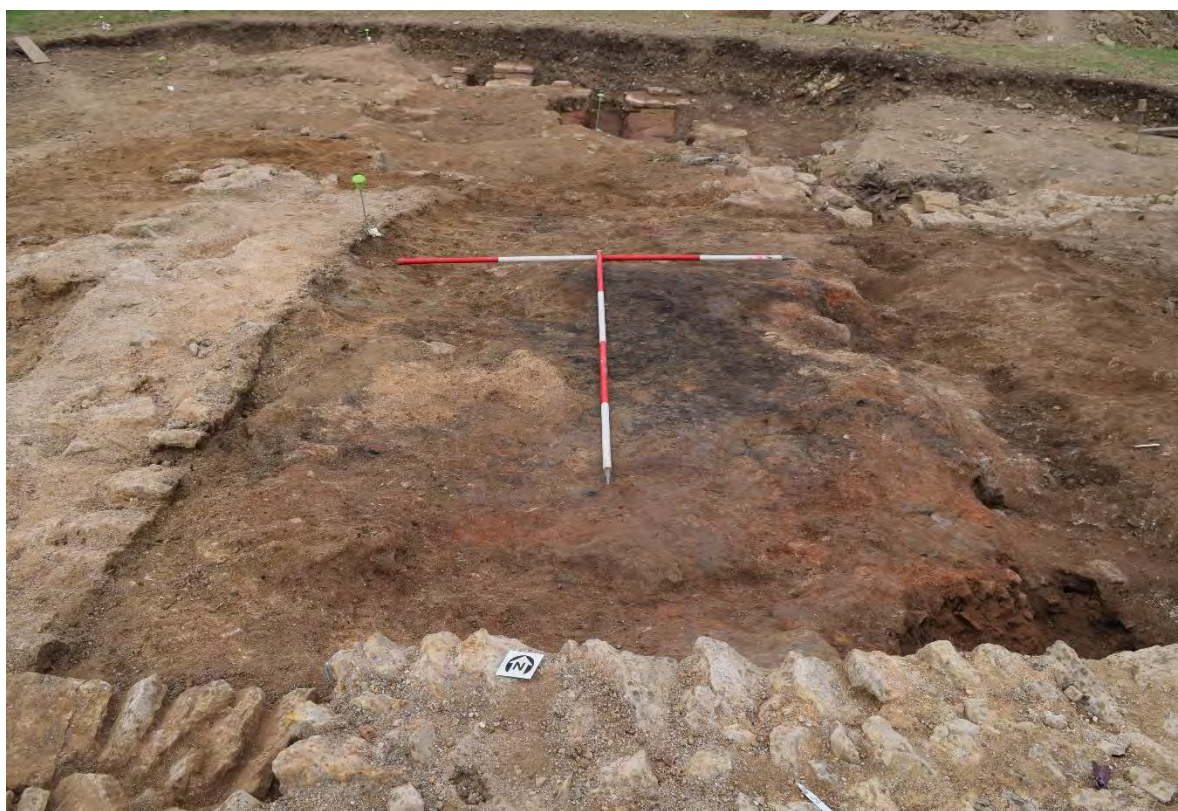
Figure 18 Interleaving burnt deposits in Room 6 [164], [166], [171]

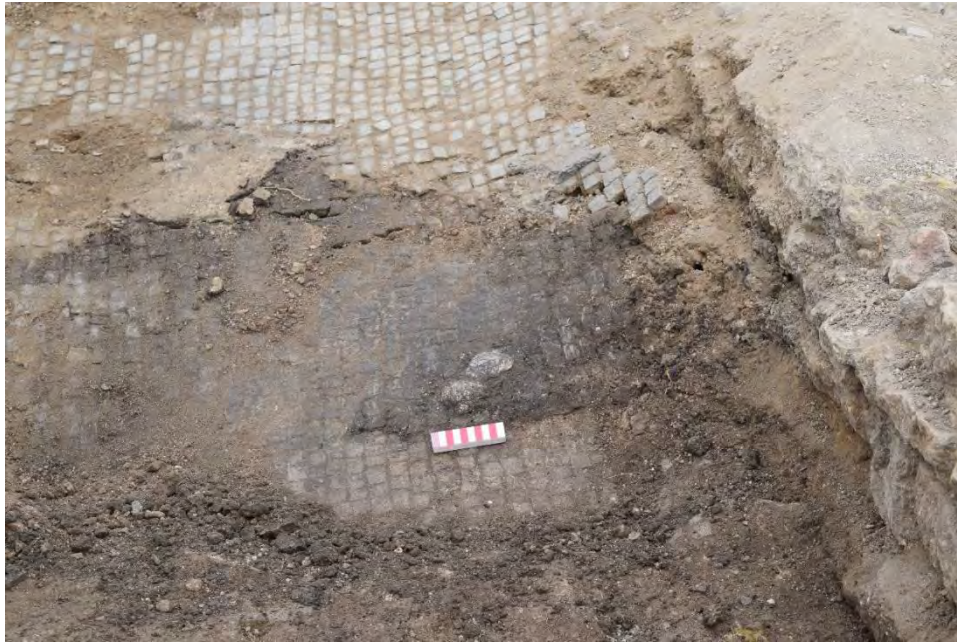
*Figure 20 Working shot of deposit [202] under excavation showing oyster shells sitting on the pavement [203]. Bone hairpin <191> was found just to the right (south) of these oyster shells on the north side of wall [114].*

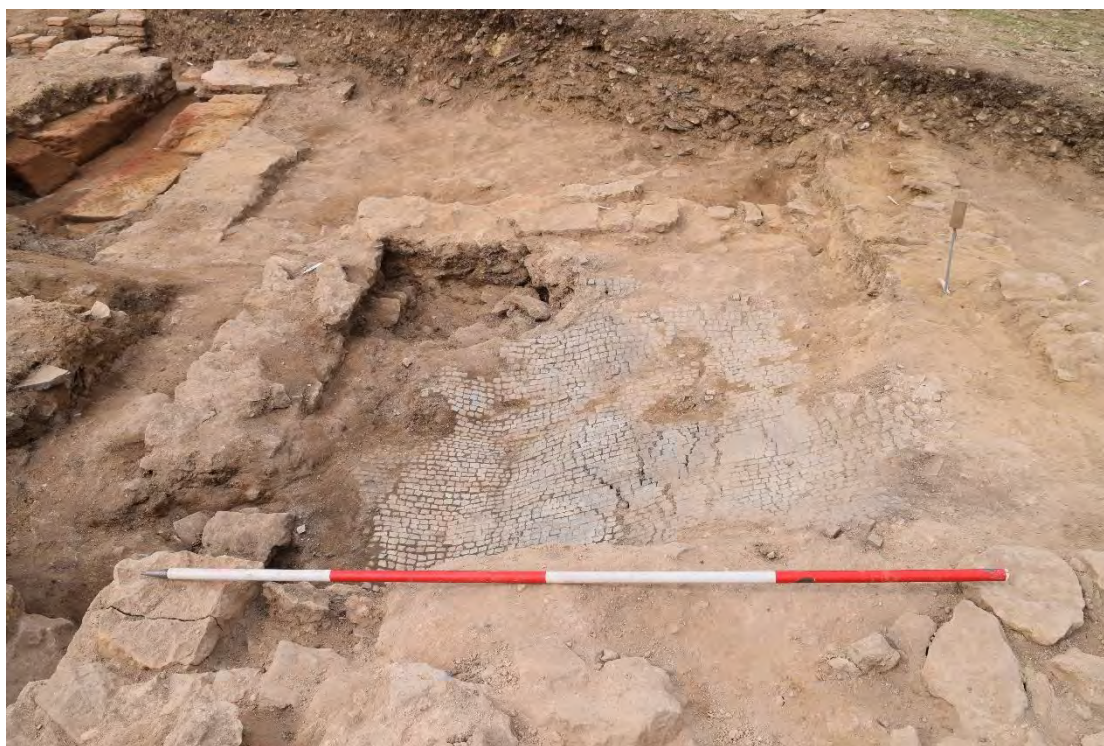
Figure 22 Room 6a looking north with Room 7 beyond. Note the character of the deposits north of wall [208] in Room 7 and also in the northern limit of excavation. No sign of Hayward's hypocaust in Room 7 is visible.

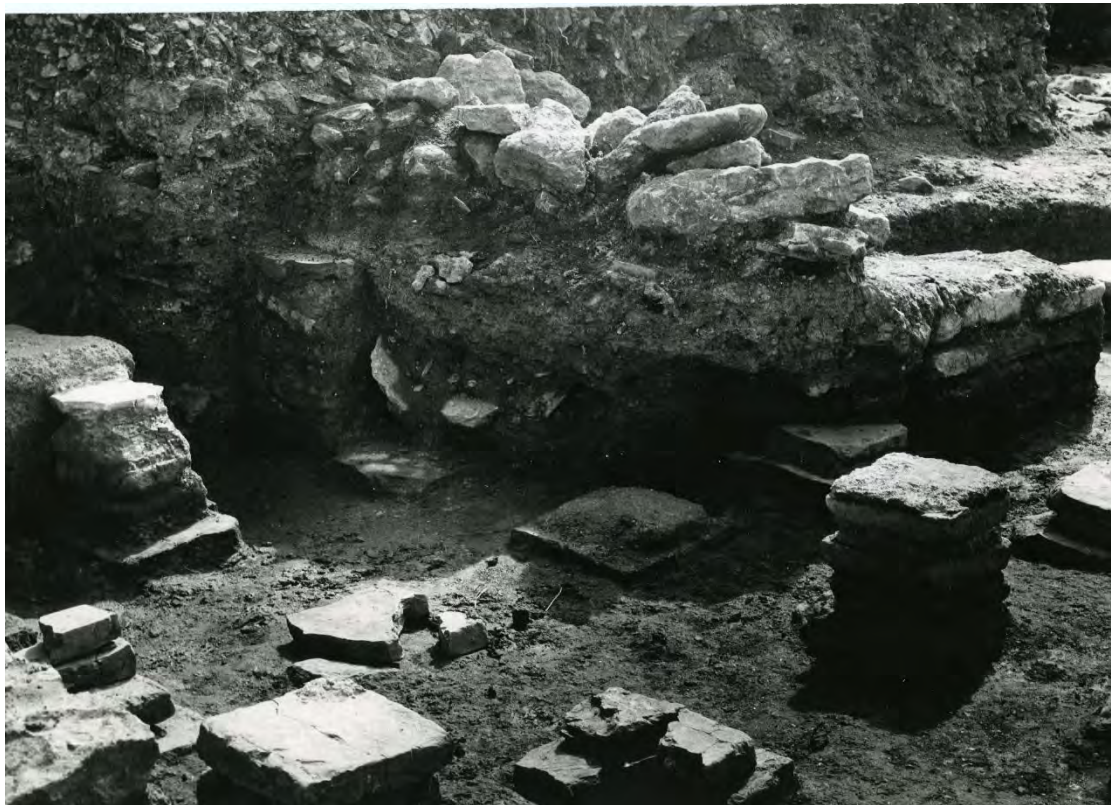
Figure 23 Photograph by Hayward showing the deposits left *in situ* in Room 10. Hayward believed these to represent the mortar floor that would have been supported by the hypocaust *pilae*. Our excavations (and this photograph) show that the mortar floor [155] overlay a deposit [158] that overlay the demolished hypocaust  
©CHAC

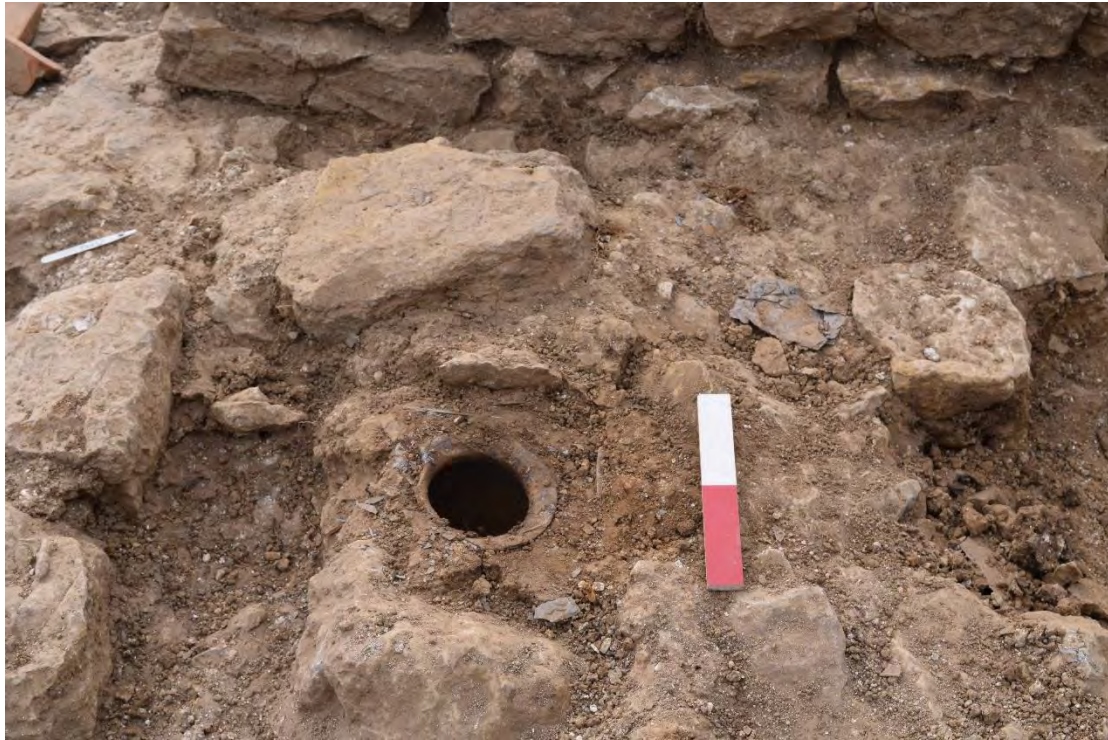
*Figure 24 Pot [145] looking west after the removal of the tegula and slate tile [144] covering the mouth of the vessel. Note the way the vessels is chocked around with stones [143] in the corner between wall stump [134] and wall [110].*

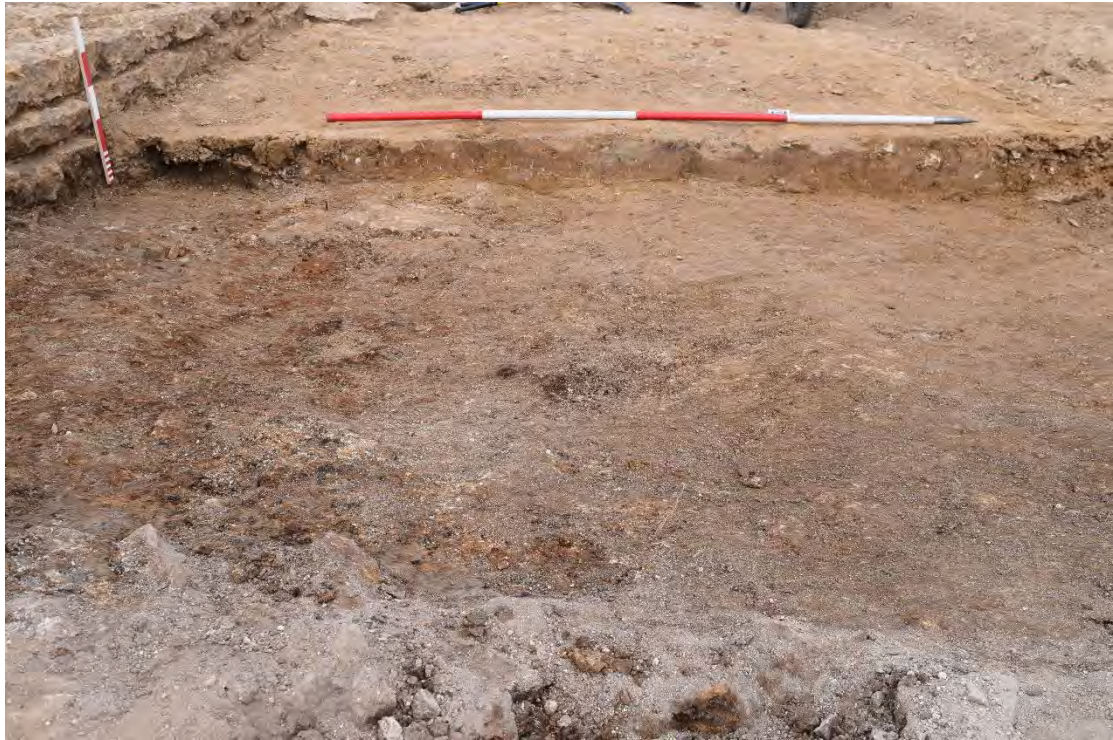
Figure 25. The southern, excavated end of the new room. This shows western wall [110] at the far left and [137] in section and lead ingot <196> in the far distance by the tools.

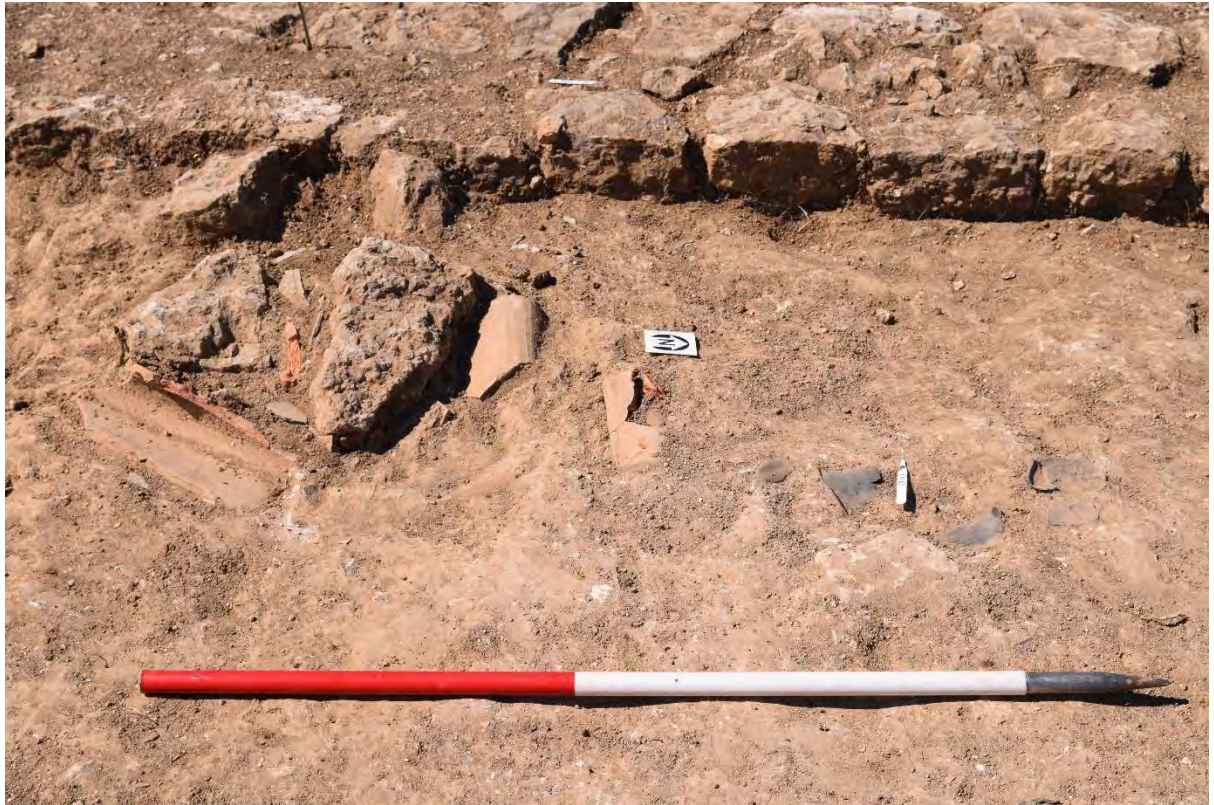
*Figure 27 Deposit of tile and pottery [116]/[129]*

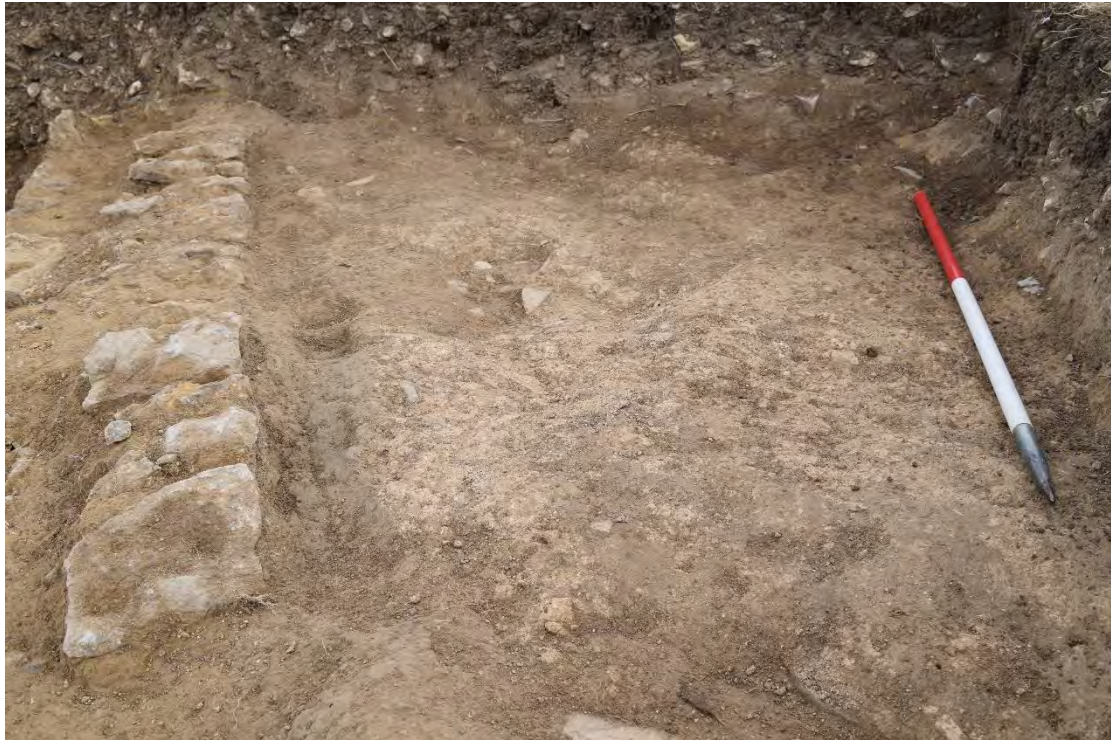
*Figure 28 Fallen plaster in Room 1 [210]. The north east corner of Trench A looking north.*

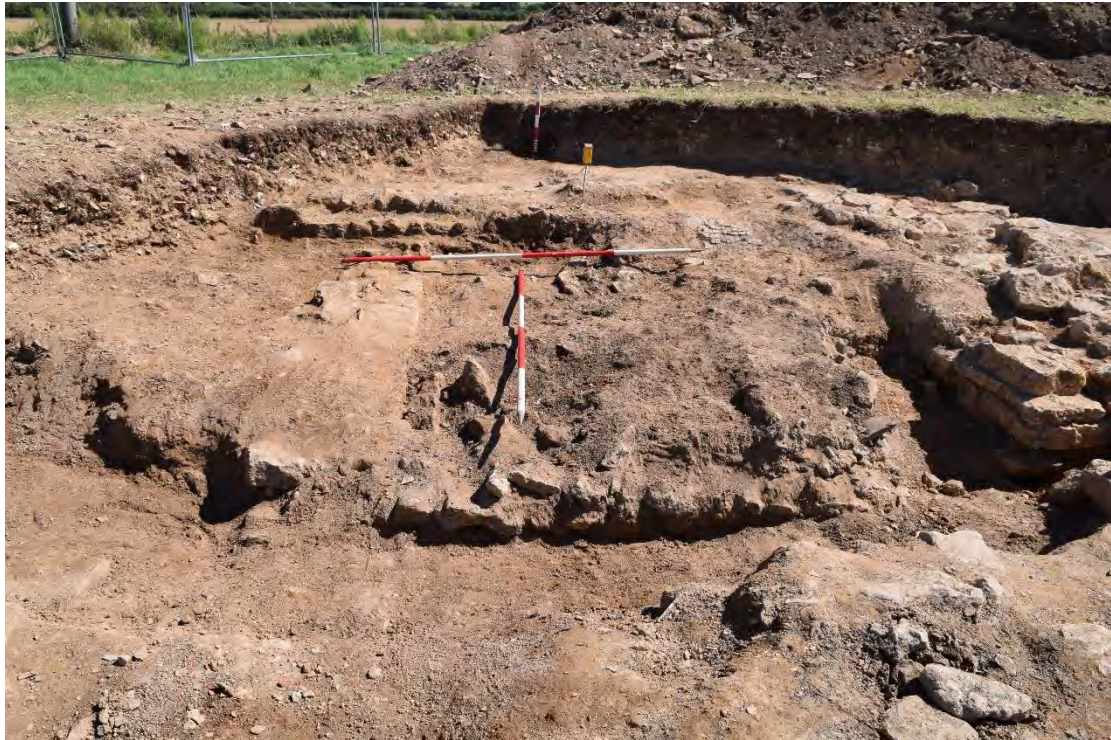
*Figure 29 Rooms 7 and Room 6a looking east before excavation. Rubble deposits [180] fill Room 6a and deposit [210] fills Room 7. Truncations in the foreground and parallel to wall [114] are thought to be related to Hayward's interventions.*

Overlying Phase D occupation deposits [202] was a firm light yellowish brown sandy silty clay containing small pieces of Hamstone and Yeovil stone as well as considerable patches of redeposited cream mortar [188] (Fig 29). This was overlaid by a firm dark brown sandy silty clay containing frequent angular and sub-angular Yeovil Stone rubble [180]. This in turn was overlain by [173] another firm light yellowish brown silty clay containing moderate quantities of Yeovil Stone rubble and fractured lias slate. [173] sealed the wall heads and expanded to the east to seal a deposit of collapsed wall plaster in Room 1 [210]. Presumably all of these deposits relate to the decay and demolition of the structure. The few finds from these layers include small quantities of late Roman pottery. These deposits were truncated by features associated with Phase G Hayward's Trenches XLVI and XVI.

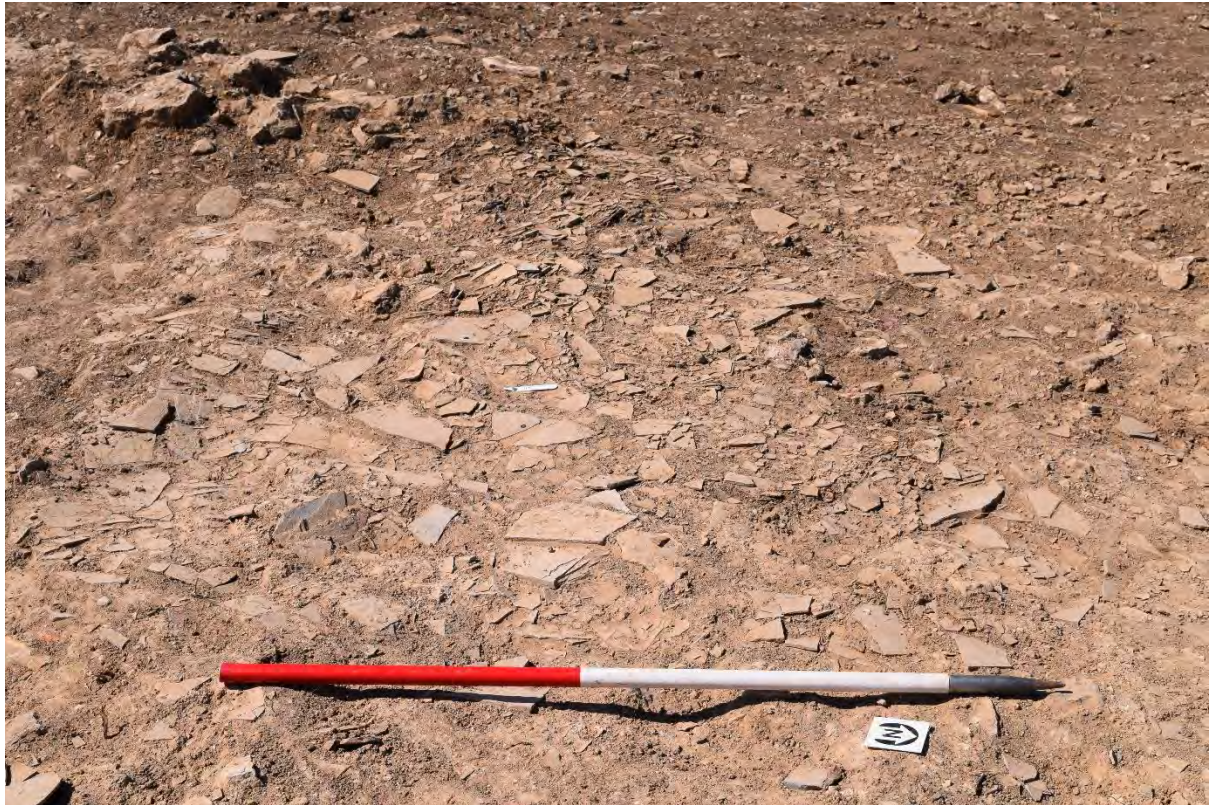
*Figure 32 Roof collapse [121] north of the new room.*

Just to the north of wall [110] a spread of smashed and splintered lias tile [121] was found sealing [137] and the line of Room 6's northern wall. This appeared to have been a deposit of *in situ* smashed roof tiles, where they had slid from the roof of the building during its collapse or demolition (Fig 32).

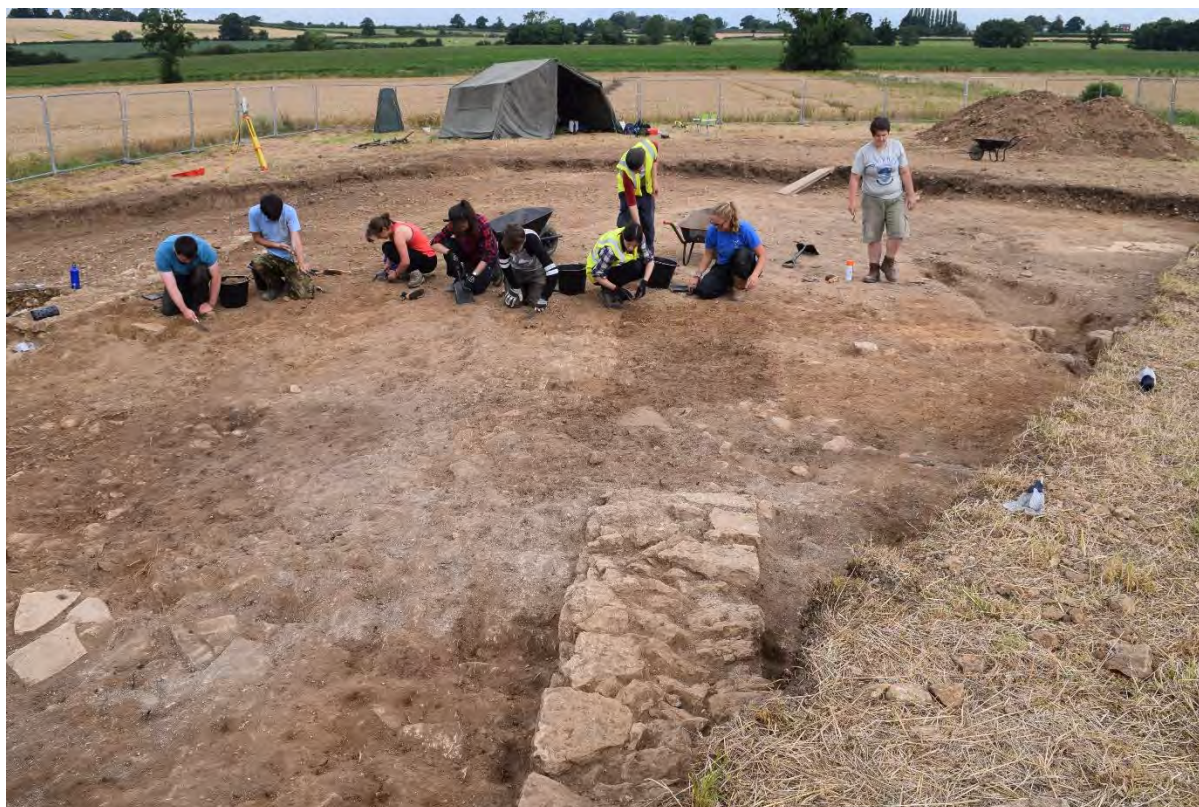
*Figure 34. Working shot (Trench A: looking north) showing the brown fill [105] of Hayward's Trench XXII [106] in line with Wall [111]. Excavated cut [109] is partially visible to the east (right) and may represent Trench XLIV.*

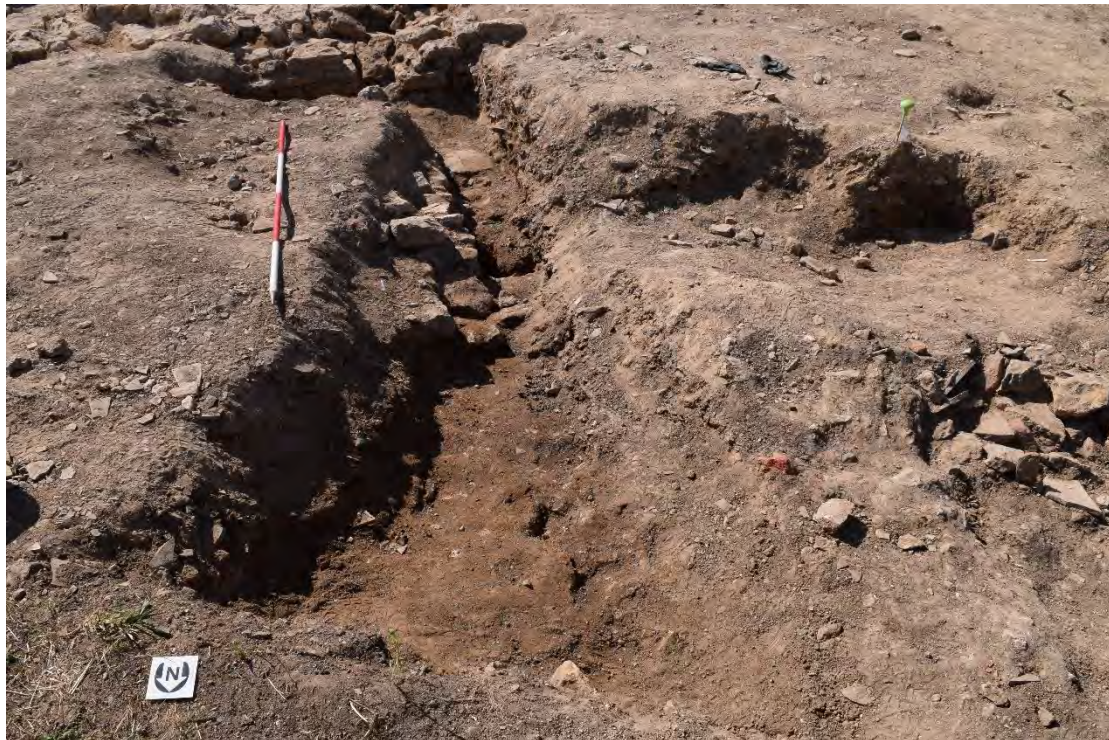
*Figure 35 Linear cut [128] looking south. To the south this feature partially correlates with Hayward's Trench XLVI but further north it becomes the complex series of interventions labelled as Trench XXVI. The dogleg of truncated deposit on the right hand side, cut by [154], can be correlated with Hayward's trench plan and [128] seems to represent Trench XXVI in Room 7.*

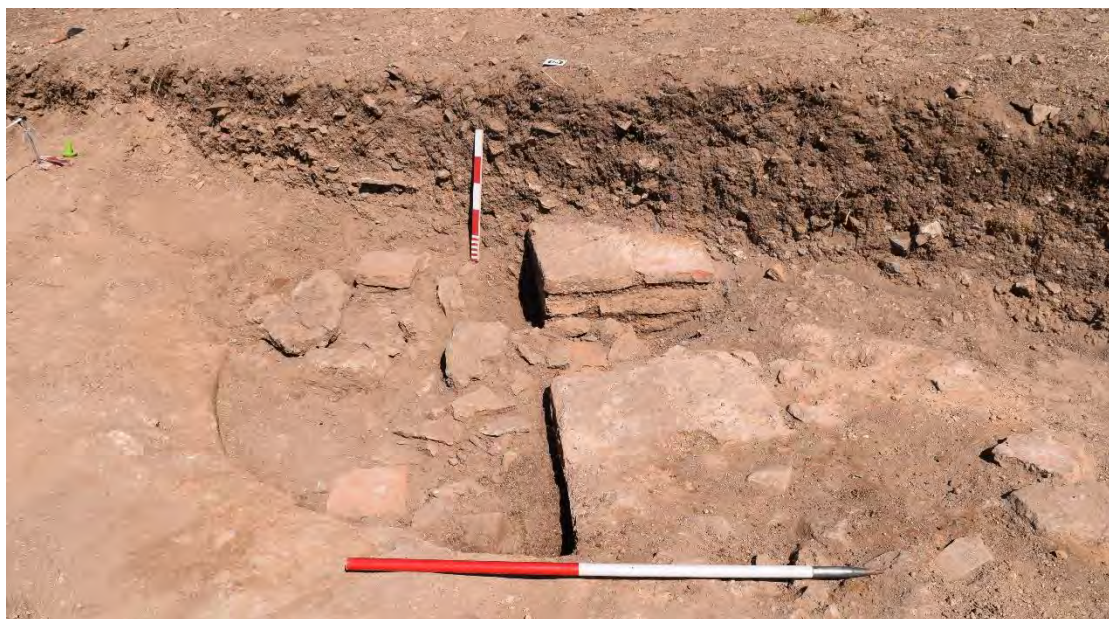
Figure 37 Rooms 10 and 11 looking north with the fill [126] of Hayward's interventions in situ.

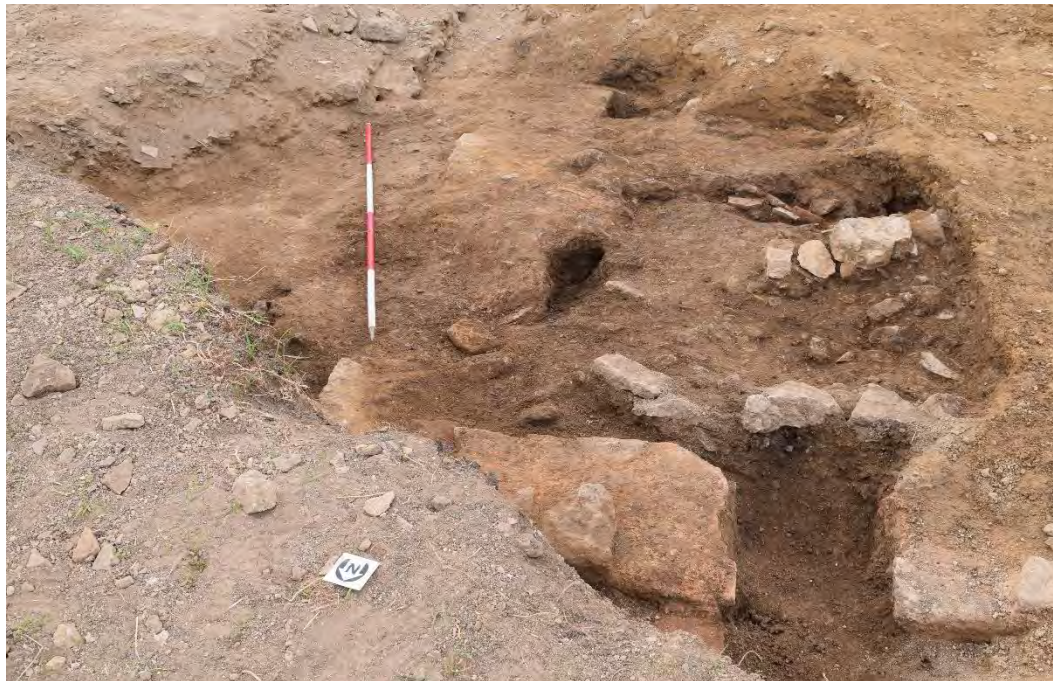
Figure 38 The flue for Rooms 10 and 11 looking south, with the fill [126] of Hayward's intervention in situ.
