# **An Archaeological Assessment of Excavations Undertaken at the Lufton Roman Villa, Brympton, Somerset, 2016-2017**

**James Gerrard and Andrew Agate  
School of History, Classics and Archaeology  
Newcastle University  
2021**

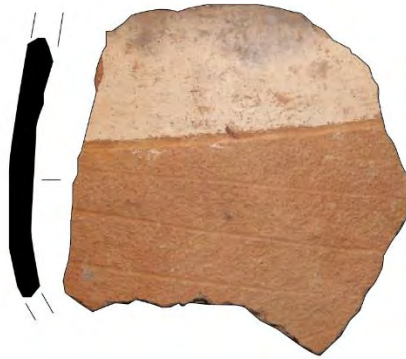
*Figure 43 Body sherd from a burnt SED BB1 vessel, possibly a Type 18 bowl (Photograph and drawing by Mark Hoyle)*

One other sherd of intrinsic interest deserves a mention here. A burnt SED BB1 sherd from a wide-bodied jar or bowl was recovered from the burnt deposits in the corridor [135] (Fig 43). This body sherd is almost certainly from a Type 18 bowl (Gerrard 2004, 2015) and should date from the very of the fourth or early decades of the fifth century. Indeed, current thinking would suggest that the type did not come into production until the AD360s, which might make this sherd one of the latest Roman objects from the site.

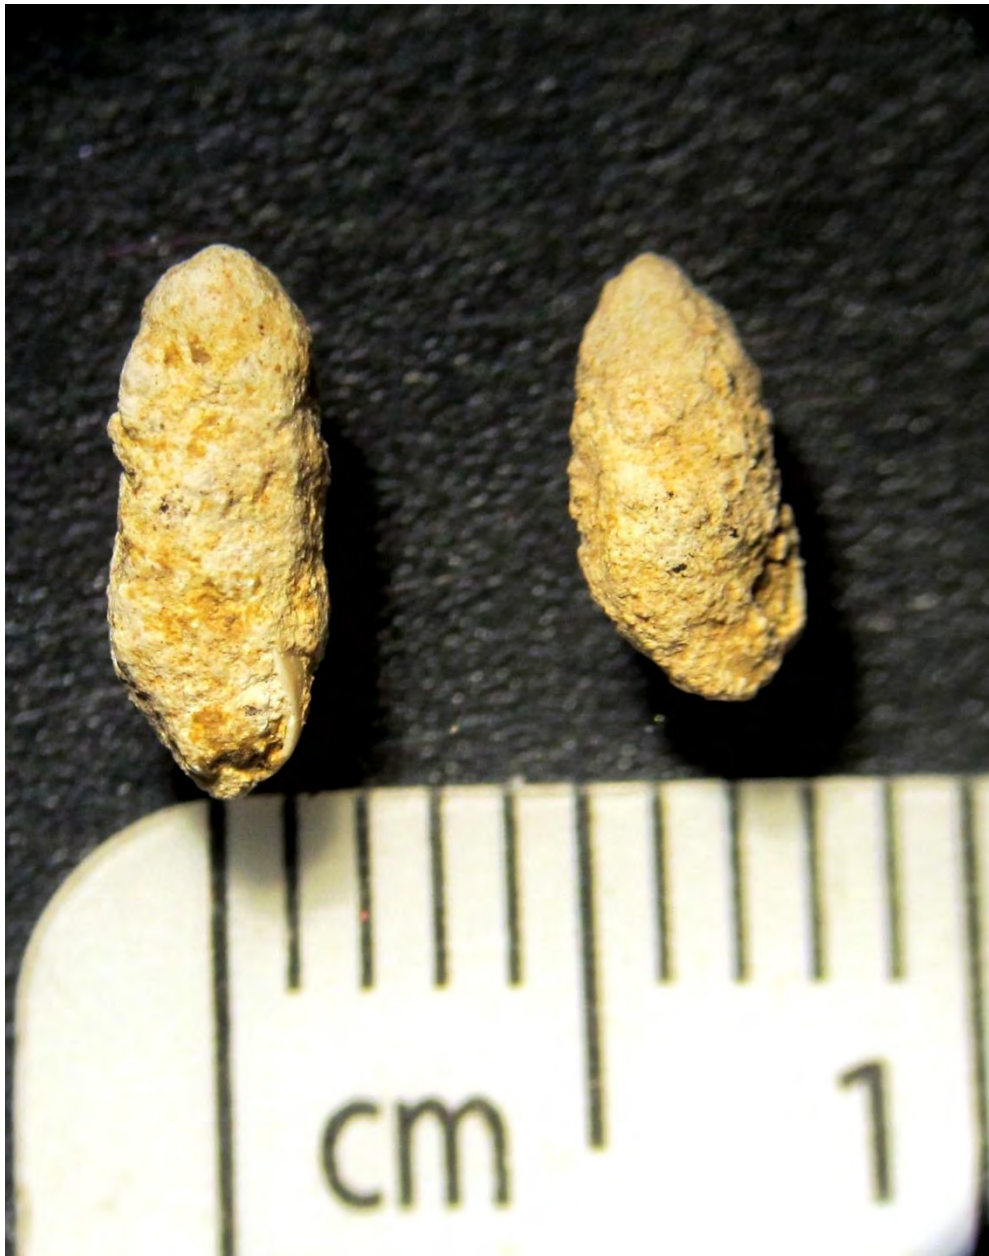
*Figure 53 Two shells of Cochlicopa lubrica with gross calcareous concretions*

Another group of snails bore calcareous concretions, ranging from relatively light to gross concretions which obscured much of the detail of the shells (Figure 53). Their association with a building may suggest that they were part of the sedimentary matrix used in lime mortar, which has been reported from later buildings in Britain (Murphy 2001; Law 2014). The gross concretions look rather more like tufa, however. The shells with calcareous concretions are mostly Group 1 species, which are associated with shady places, as well as small numbers of Group 5 taxa (and two ostracod carapace valves), found in marshy conditions. This a good fit for tufa deposition in a spring line in wooded conditions, like many other tufa sites in Somerset and further afield (Davies 2008, Chapter 6).

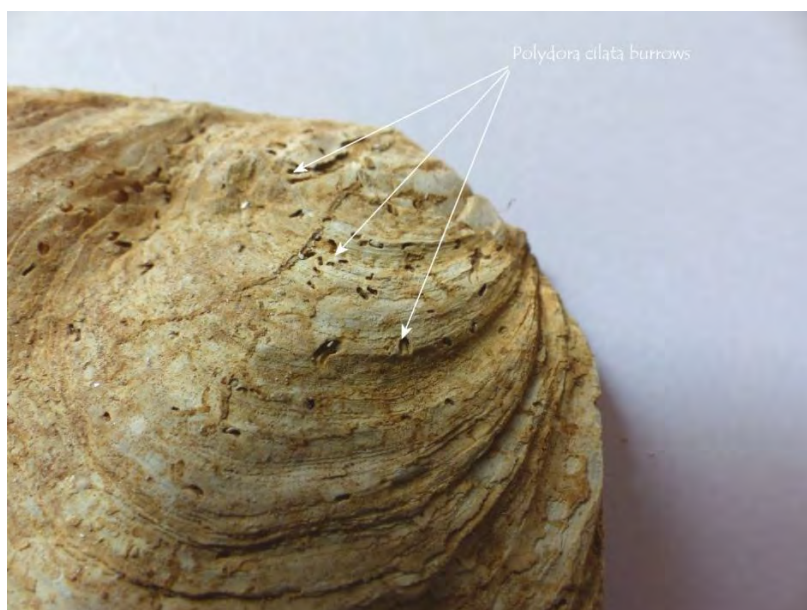
Figure 54 Oyster right valve outer surface showing burrows of mud-tube worm *Polydora ciliata* from LUF16 [121]

The most commonly occurring type of evidence for organisms that infested the oyster shells during their life are the small burrows of the marine polychaete worm *Polydora ciliata* Johnston. In the Lufton oyster shells this has a very low frequency of occurrence. The burrows appear as small dumb-bell shaped holes and approximately U-shaped tunnels anywhere on the surface of the shell (see Figs 54, 57 & 58). This worm species is ubiquitous around the British coastline in shells and rocks therefore it has limited use in determining the location of the place where the oysters were collected.

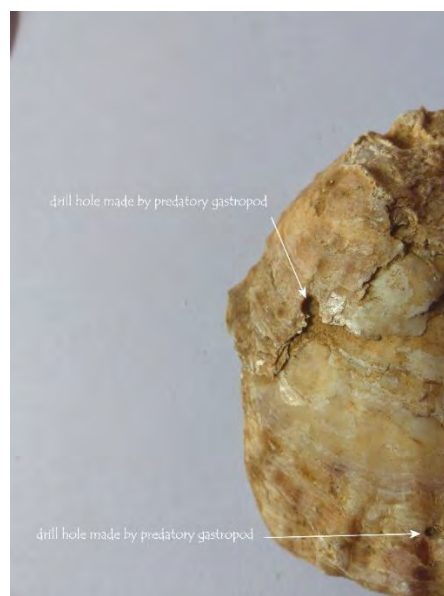
Figure 59 Oyster left valve outer surface showing bore holes made by a predatory gastropod such as the sting winkle *Ocenebra erinacea* from LUF16 [121]

These neat circular holes usually occur singly, though there may be more than one on the shell. They are made by certain carnivorous gastropod molluscs which use a toothed radula (a tongue like structure extruded from the head) to drill through the shell to eat the meat of the animal within. The sting winkle (*Ocenebra erinacea*) is an example of a gastropod mollusc that likes to predate oysters. They are not always successful in their drilling activities. They are most likely to totally penetrate the shell in younger oysters with thinner shells (Fig 59).

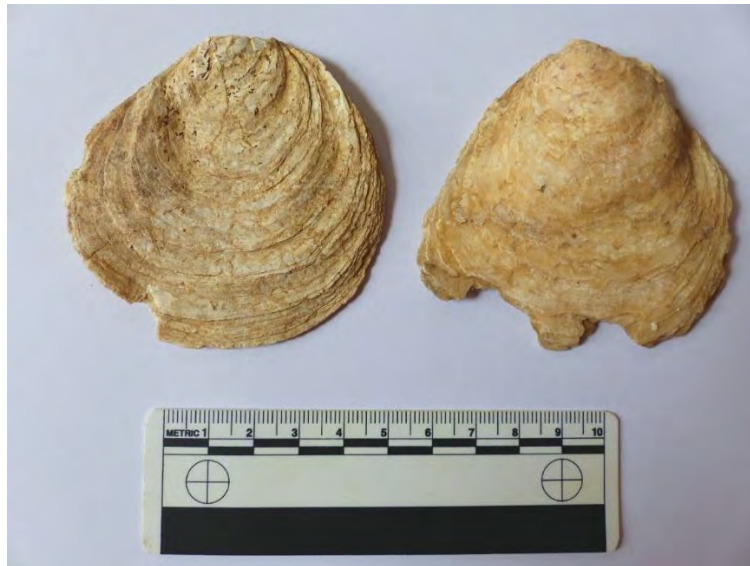
*Figure 60 Marginal notches on oyster shell right valves from LUF16 [121] which may indicate damage caused by opening the oyster to get the meat. The two notches on the right shell look original but the notch on the left is uncertain.*

Cuts and notches on oyster shells may indicate damage caused when the oysters were opened. They can take the form of V- or W-shaped notches on the lower margins of the valves where knives or other implements have been inserted and twisted to lever the valves apart and get the meat. There are several shells in which peripheral notches have been recorded in the Lufton samples but there is uncertainty as to whether these are original or represent post-excavation damage. Examples of these notches can be seen in Figures 60 and 61.

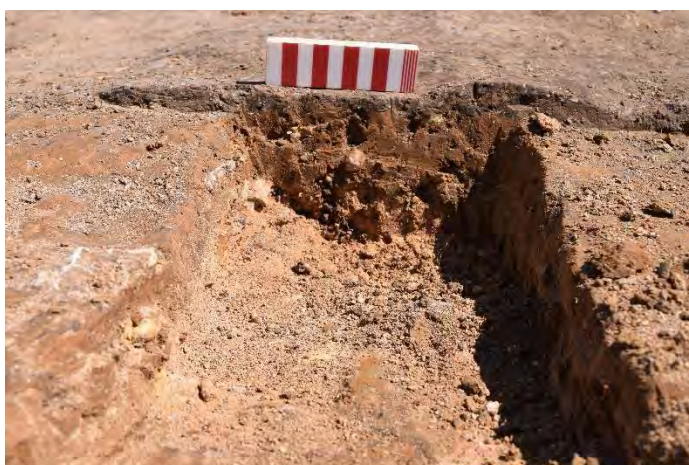
Figure 62 Section through [171], [174] and [201] sampled for micromorphology.

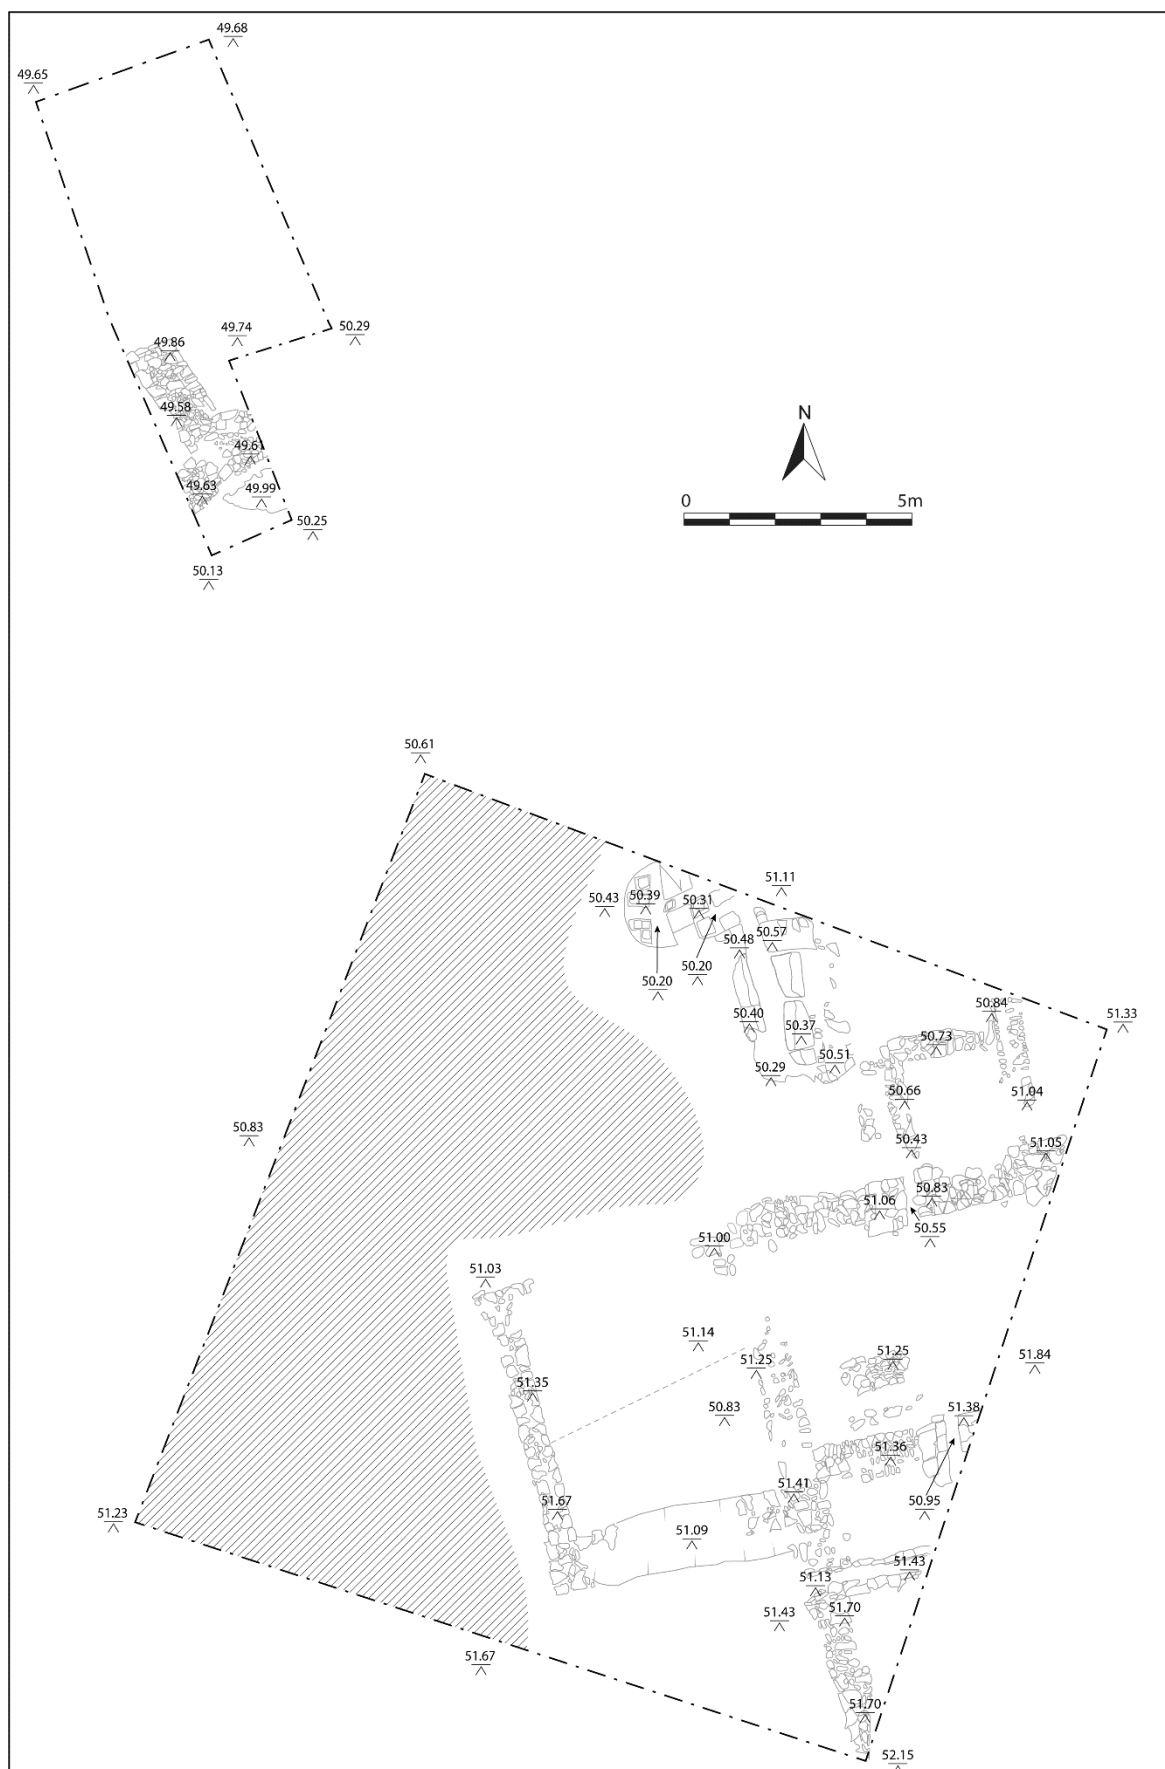
Figure 64 Reduced levels on the modern grounds surface and key architectural features. Further levels on individual contexts can be found in the site archive. Hatched area was unexcavated.
